MISCELLANEOUS PAPER S-73-51

CONDITION SURVEY, LORING AIR FORCE BASE, MAINE

R. D. Jackson

June 1973

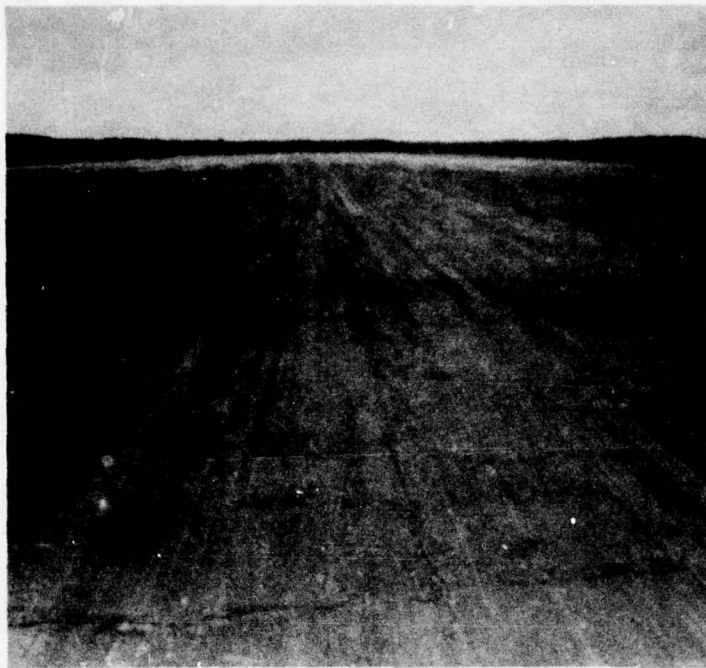
Photo 1. Crack on AC portion of N-S runway
near north end

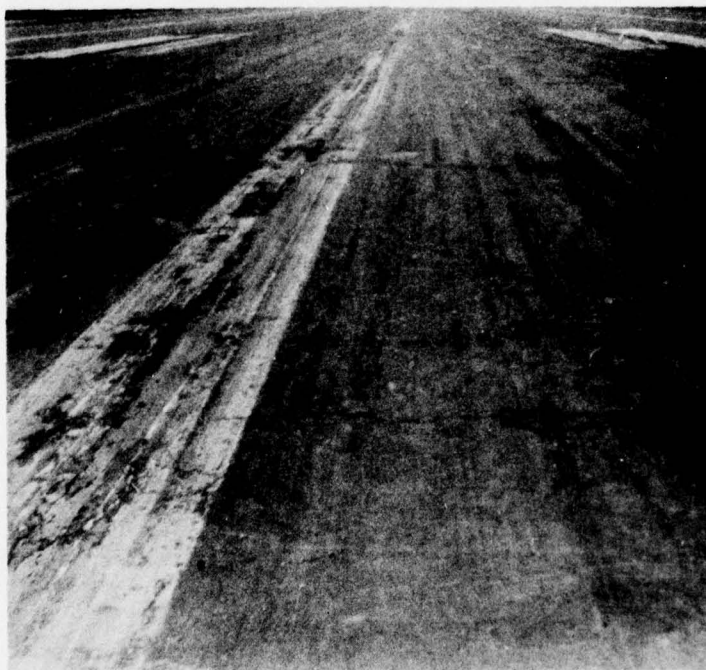
Photo 2. Cracking on N-S runway near
north end of AC pavement

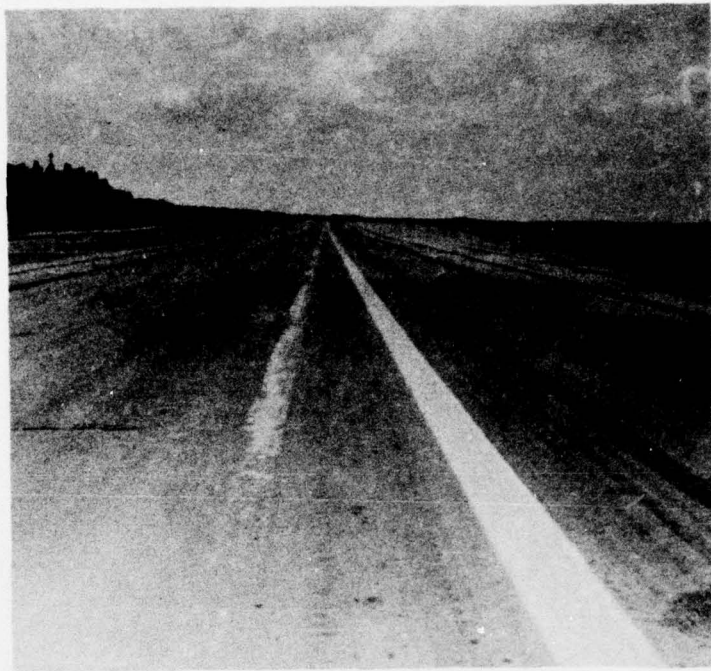
11. Taxiway A from taxiway B to the dogleg (see plate 1) was in good condition, since a chip seal was applied during the time of the survey. The extension to taxiway A was in good condition (photo 3). The PCC portions of taxiways D, E, and F and taxiway G were in conditions ranging from poor to very good (photos 4 and 5). The predominate defects in these taxiways were longitudinal cracks, and more than 50 percent of the cracks were in the center lane. Taxiways B and C were in good condition. The AC portion of taxiway D was in excellent condition; it had recently been overlaid. The north connecting taxiway, which contained 111 major defects, was in a poor to failed condition; however, the facility was still serviceable since little or no movement was observed at the locations of the major defects. Photo 6 shows some of

Photo 3. Extension to taxiway A

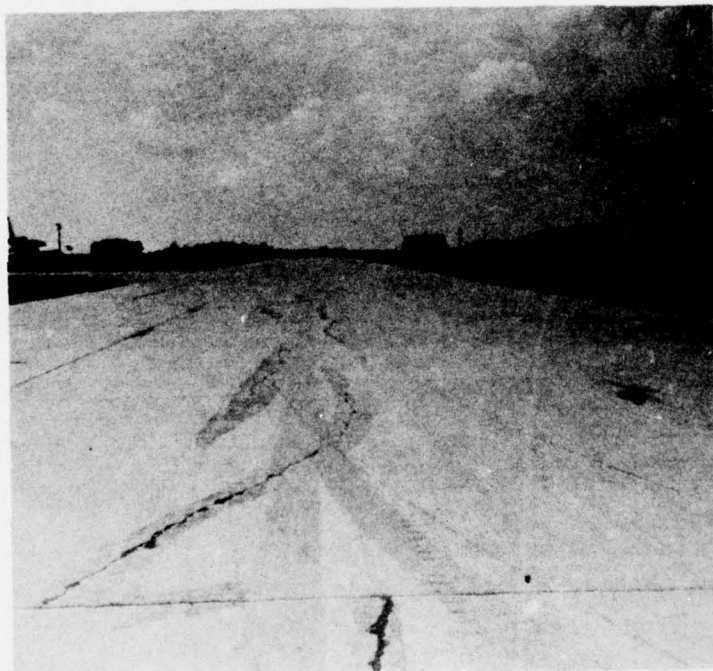
Photo 4. Cracks in taxiway E west of
intersection with taxiway G

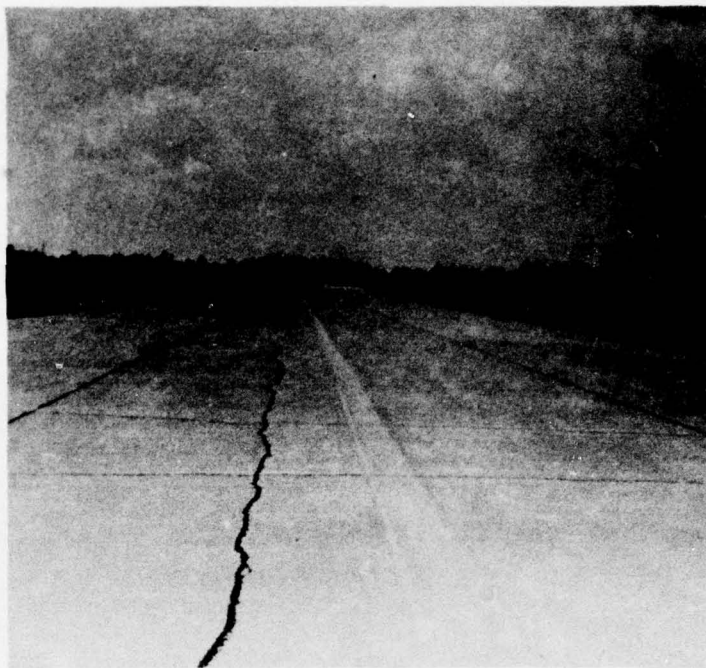
Photo 5. Cracks in taxiway G

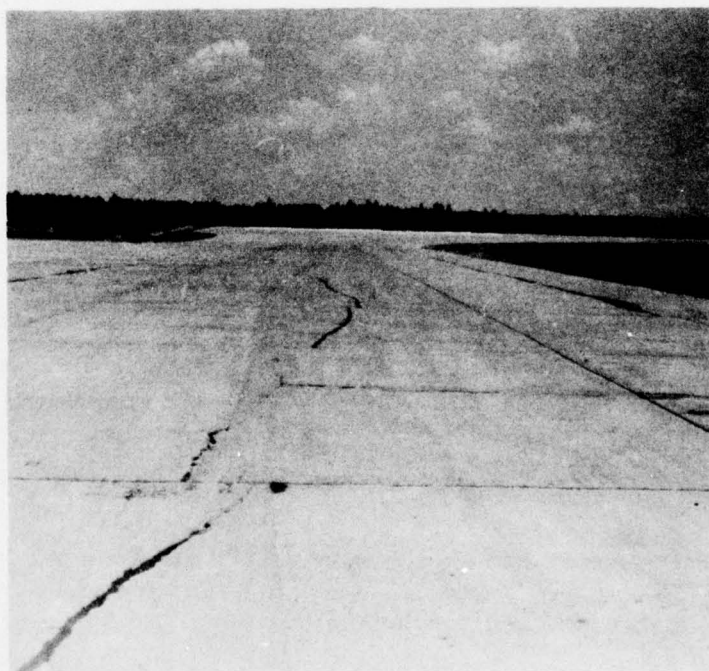
the cracks in this feature. The AC portions of taxiways E and F were in good condition.

Photo 6. Cracks in north connecting taxiway

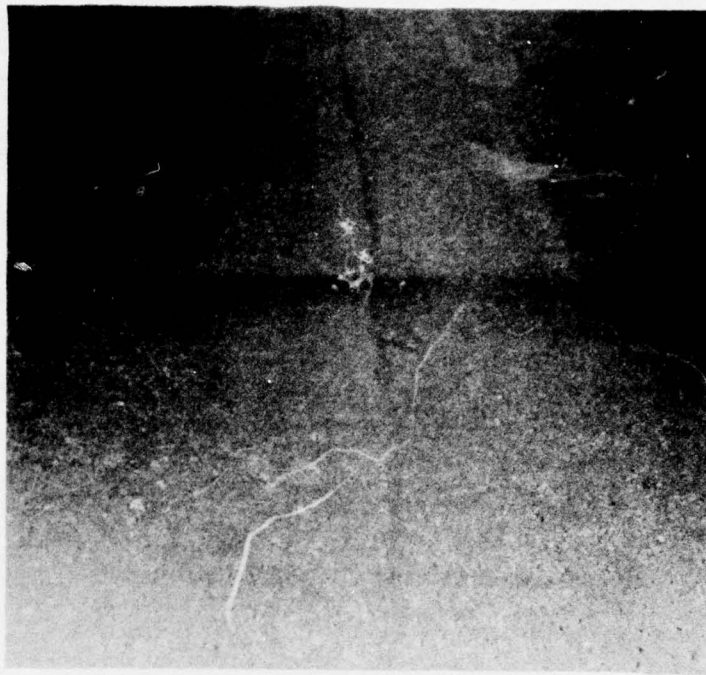
12. The parking and maintenance apron west of the apron taxiway was in good condition. A tar rejuvenator that sealed the smaller cracks and partially filled the larger cracks was applied to this area in 1971 (photos 7 and 8). The area of the parking and maintenance apron east of the apron taxiway was in only fair condition; the tar rubber surface contained many cracks. The north warm-up apron (feature AlB) was in a poor to failed condition. A total of 179 major defects were observed in this feature, of which 120 were longitudinal cracks. Parking apron 1, which is essentially a taxiway with parking stubs, was in fair to good condition. The taxiway portion between taxiways D and F had a chip seal coat applied during the time of this survey. Photo 9 shows the relatively good condition of stub 8. All of the stubs of parking apron 1 had a tar rejuvenator applied in 1971. Parking apron 2 is the same type of facility as parking apron 1. The south portion of taxiing area had a chip seal coat applied during the time of this survey. The PCC taxiway portion of apron 2 was in poor condition structurally. The bituminous concrete parking stubs of this apron were in fair condition. Photo 10 shows the condition of stub 23, which was typical of the flexible pavement stubs in this apron. The PCC stubs were in poor to fair condition. The stubs of parking apron 3 were in fair to good condition, as were those of parking apron 4. The taxiway portion of parking apron 5 was in fair condition, and the stubs were in conditions ranging from poor to very good.

Photo 7. Close-up of parking and maintenance apron. Tar rejuvenator was applied in 1971

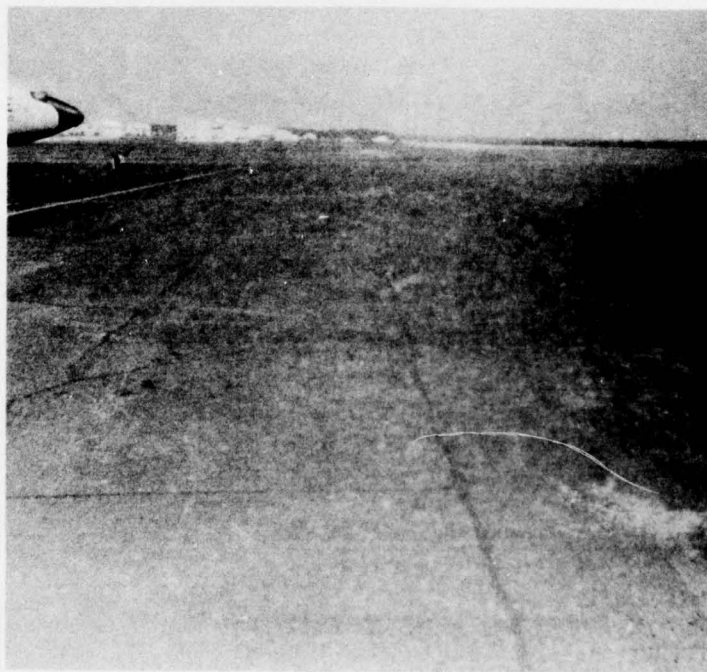
Photo 8. General view of parking and maintenance apron

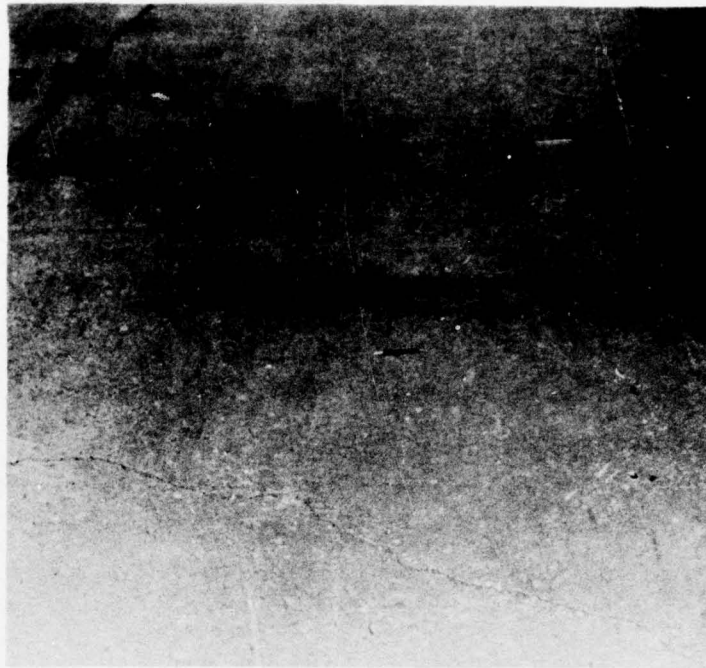
Photo 9. View of parking stub 8. Tar rejuvenator was applied in 1971

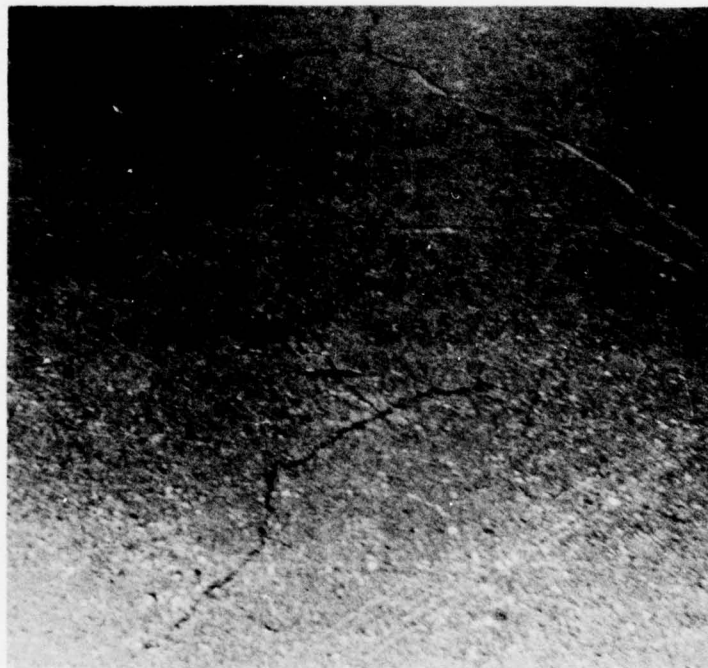
Photo 10. View of stub 23 (typical of AC stubs)
